INSPECTION REPORT: BY W. Douglas Smith, Tue, May 25, 1993

## RCRA INSPECTION REPORTIVE

### MAPCO Alaska Petroleum Inc.

5/10-14/93

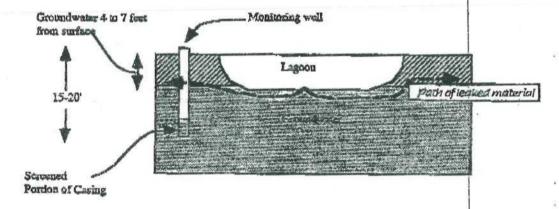
#### Theoretical petroleum contaminant leak:

lagoons. She said that the ground water varies between 6 and 7 feet. I obtained information from the state indicating that it may be as high as four feet several times a year. Ms. McCullom said that the monitoring wells are screened at 15 to 20 feet from the surface. She said that the monitoring wells have not indicated any leaking or contamination that exceeded the 5 ppb benzene set by the state. I asked her if there was any concern that contamination from the lagoon might float on the ground water and escape undected in the 4-7 foot zone and that her monitoring wells might not detect it because they were screened far below the surface of the ground water. See diagram of my hypothesis:

Ms. Blevins and I thought that it might be possible for sludge to build up in the bottom of the lagoon. A leak in the bottom of the lagoon might have oily residues that might be heavier than water as sludge but might float if disturbed by movement. I asked Ms. McCullom if she felt satisfied that her wells would detect all leaks from the lagoons. She said that she had complete confidence.

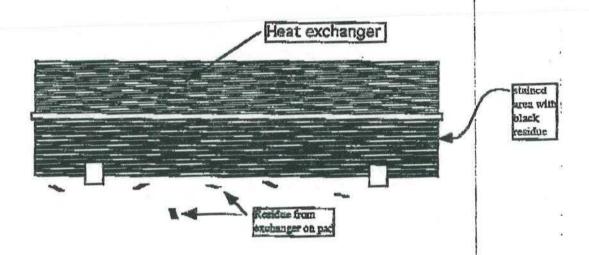
K050 waste stored more than 90 days without proper waste management:

During the inspection of the yard and operations area I observed two heat exchanger bundles (See video footage 205-243 and INSPECTION REPORT: BY W. Douglas Smith,

1909-2022) The larger of the two units was darker on its bottom half. I asked Ms. McCullom how the units were removed. She said that they were pulled and the dripping K050 waste was collected and shipped as hazardous waste. I asked her if the units had been pressure washed or cleaned. She said that she didn't know. I then looked closely at the units and determined that the bottom half of the larger unit appeared to have a residue like black soot. This material may be scorohed Sulfaline used in the heat exchangers. The residue on the bottom portion and a comparison with the rusted upper portion is clearly shown in the video tape (see video footage 1909-1022). Heat exchanger sludge is a listed K050. The residue was not believed to be an acute dermal toxin according to Ms. McCullom.

Ms. McCullom thought that the two heat exchargers on the pad were changed out in the fall or late summer of 1992. I observed at least 6 other heat exchangers of similar size on the west side of lagoon C (approximation). I asked her how long those units had been stored and she thought that they had been there about the same time. She said that they were determining costs for waste disposal, scrapping or rebuilding. She said that she would provide documentation.
